2014 FAA Worldwide Airport Technology Transfer Conference

REHABILITATION OF WATER-DAMAGED RUNWAY COMPOSITE PAVEMENTS

Narita International Airport Corporation

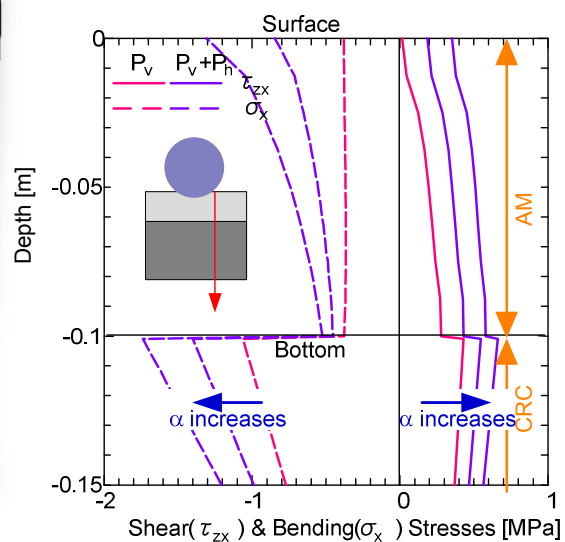
CASE 1

- ✎ In CASEs 1 and 2, stress between AM and CRC is larger than AMs.
- ✎ In CASE 3, stress between AMs is much larger than AM and CRC.

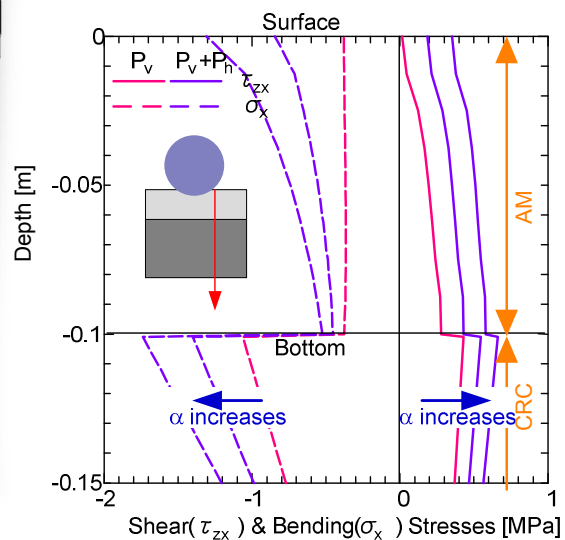
CASE 1

- Stress in CASE 3 is larger than CASEs 1 and 2.
- Little risk of separation between AMs as long as the bonding is secured.
